Artifacts In Peripheral Vascular Ultrasound Caused By EKOS

Section of Cardiology, China Medical University Hospital, Taichung, Taiwan

Introduction

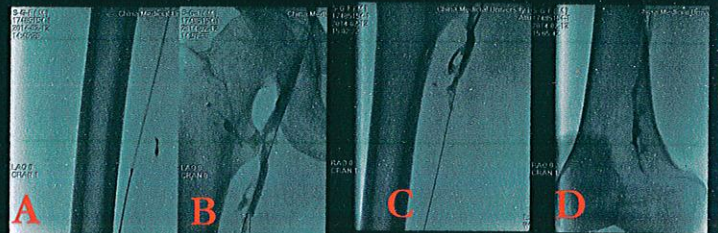
Figure 3. (A) 4Fr Fountain catheter in RSFV to deliver urokinase (B-D) residual thrombus over RSFV

A 4 Fr Fountain catheter was advanced to right SFV and urokinase infusion was given overnight, however much residual thrombus was still noted over right SFV (Figure 3)

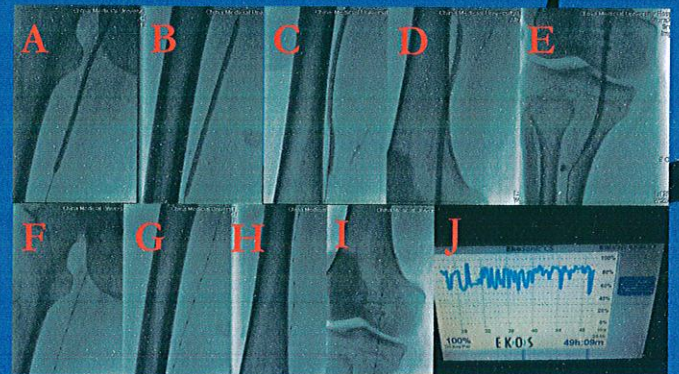
Figure 4. (A-E) Serial balloon dilatation of RSFV for fragmentation of thrombus. (F-I) EKOS catheter (J) EKOS machine showing average power.

After serial balloon dilatation, EKOS catheter was placed over RSFV with urokinase infusion and EKOS machine was turned on to deliver ultrasound energy to pump urokinase directly into RSFV and R pop v. (Figure 4)

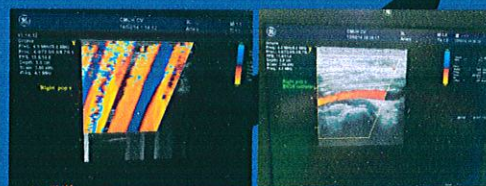
Figure 5. Ultrasound study of right popliteal vein. (A) When EKOS is turned on. (B) When EKOS is turned off.

We performed routine ultrasound follow up at bedside. However, severe artifacts were noted. We thought it was malfunction of our ultrasound machine but the engineer can not find anything wrong. Finally we found no more artifacts were noted after we turned off EKOS machine. (Figure 5)

EKOS will deliver ultrasound energy from vessel lumen, which will interfere the ultrasound beam from ultrasound probe, hence cause artifacts. One should turn off EKOS machine when vascular ultrasound is performed.
